Alaska Village Erosion Technical Assistance Program

An Examination of Erosion Issues in the Communities of Bethel, Dillingham, Kaktovik, Kivalina, Newtok, Shishmaref, and Unalakleet.

April 2006

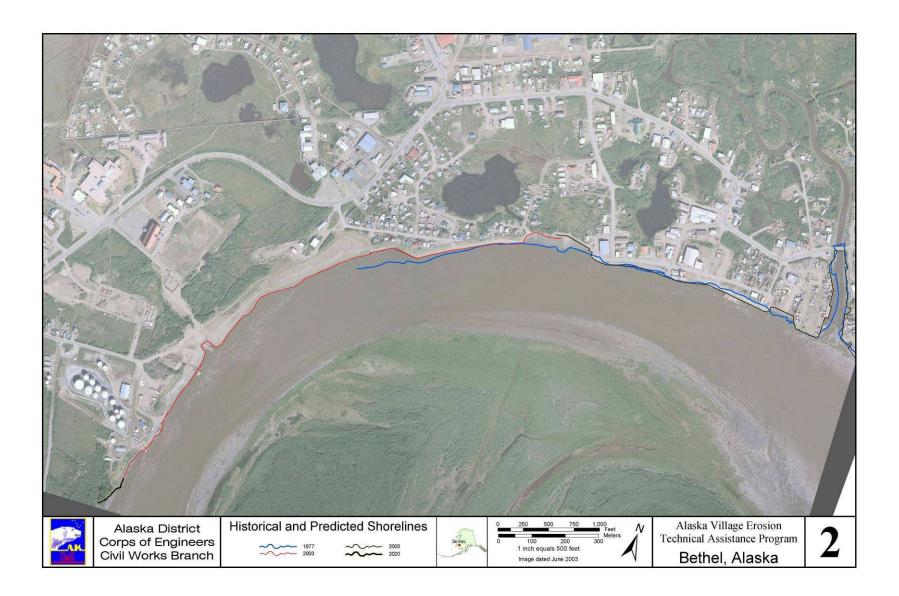
Obvious outward bowing of wall.

Although Bethel is not in imminent danger, it has experienced serious erosion and has undertaken various infrastructure-specific activities to resolve this problem. The Corps has a project underway to repair the seawall by placing more rock, by replacing a steel tieback system, and placing steel wale on the inland side of the pipe piles. The project will reinforce the seawall 1,200 feet so that it protects the entrance to Bethel's small boat harbor. The initial cost estimate for this project in 2001 was over \$4.7 million. The project should be completed in 2006. Because of these measures, there are no plans for Bethel to relocate or collocate to another site.

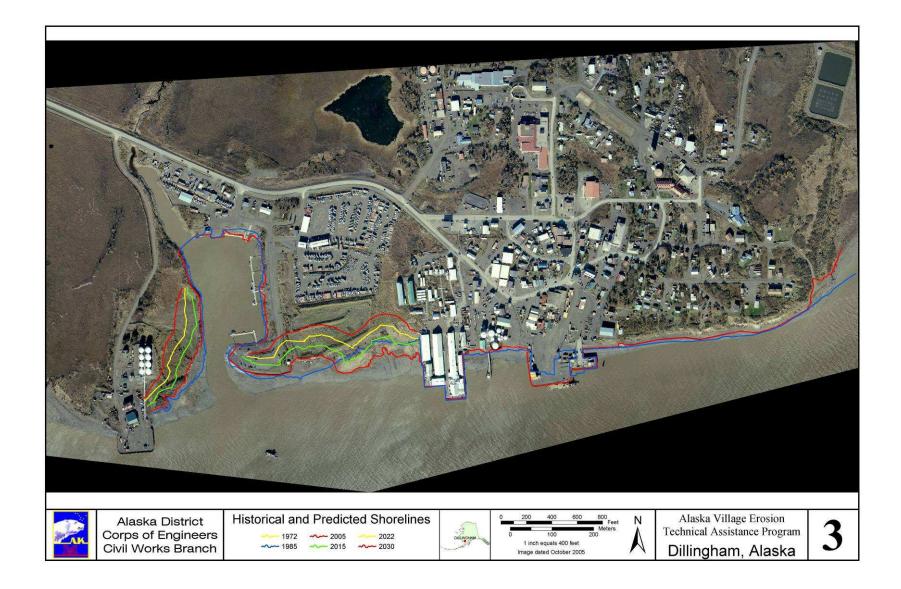
Corps protection on harbor east bank

A project to protect Dillingham Harbor and the surrounding facilities is nearing completion of the planning phase and the beginning of the design phase. Typical annual storms are causing land to erode along the west bank of Dillingham Harbor. As seen in the photos above, the waves enter the harbor and continually erode the west bank. The east bank has already been protected by a Corps project. Erosion at the west side of the harbor entrance is also fueled by wave action in conjunction with high tides. Currently, the west bank of Dillingham Harbor is eroding at an average rate of 11 feet per year. If left unchecked, the continued erosion would lead to a significant decrease of harbor protection. In addition to reduced bank protection for the harbor, floats, and commercial fishing fleet, land as well as the majority of the fuel supply for the area would be lost. Construction of this project is scheduled for 2007.

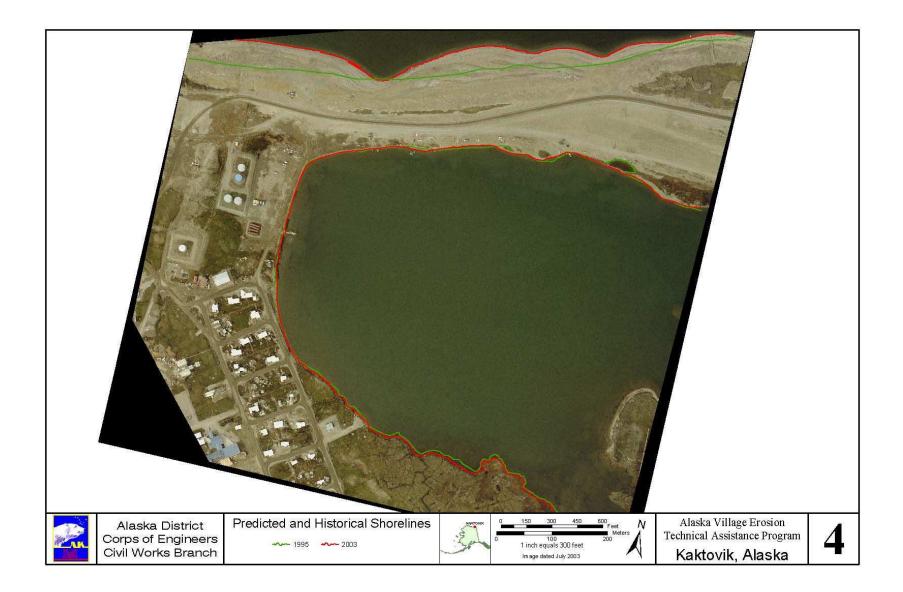
Shoreline Erosion

The only notable erosion that has had a direct effect on the community is along the frontage within the lagoon (Pipsuk Bight). Protection of this area was provided in the 1990's by construction of a timber crib wall. This structure has performed well and has essentially stabilized the area such that erosion is not a problem for the community along this portion of the lagoon.

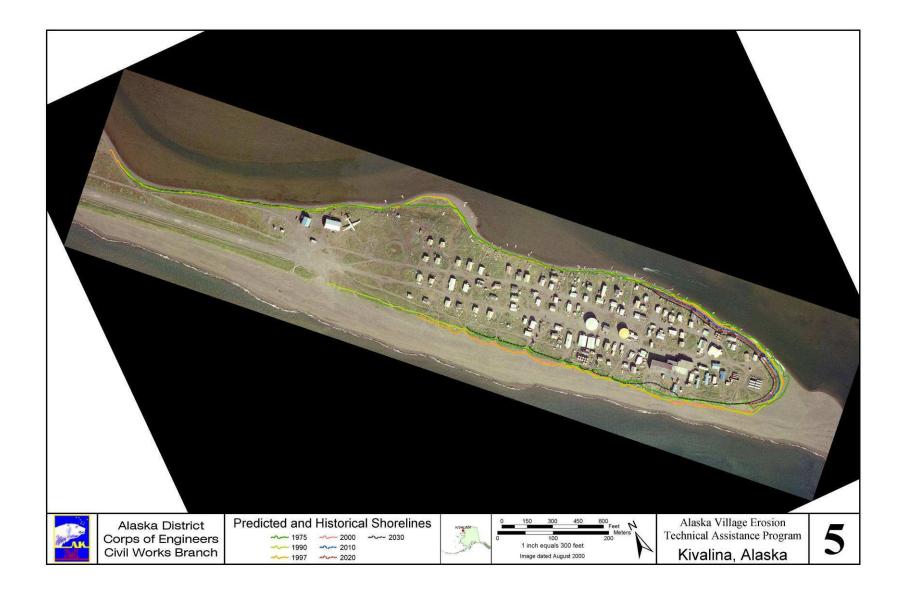
Emergency shoreline protection - 2005

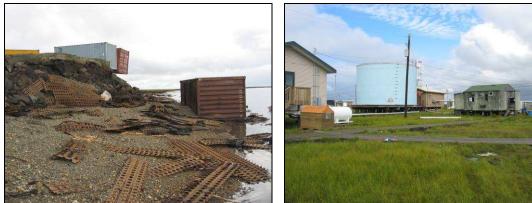
Typical Newtok Erosion

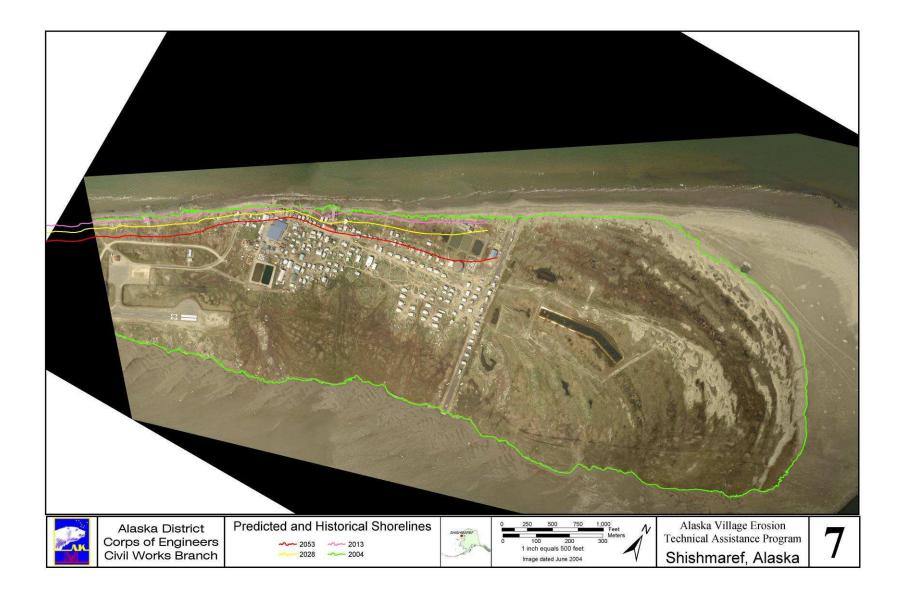
Old articulated concrete mat project

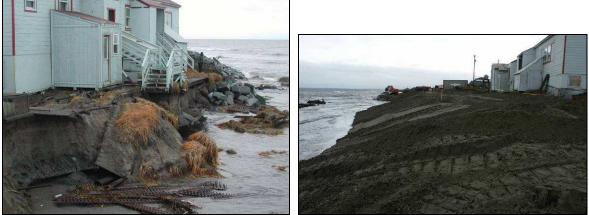
BIA protection in foreground in 2003.

Post Fall 2004 Storm

Corps Project Under Construction in 2005

Recently the Bureau of Indian Affairs (BIA), the City of Shishmaref, and the Corps have invested in shoreline protection along the community of Shishmaref. In 2004, the BIA installed 200 feet of shoreline protection along the shoreline near the Native store. In 2005, the Corps installed 230 feet of protection, connecting to the BIA project, extending to the east to protect the Shishmaref School. Also in 2005, the community of Shishmaref installed about 250 feet of protection extending to the east from the Corps project.

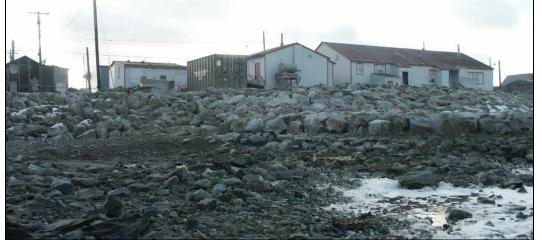
Post Construction - Corps Project to Right / City Project to Left in 2005

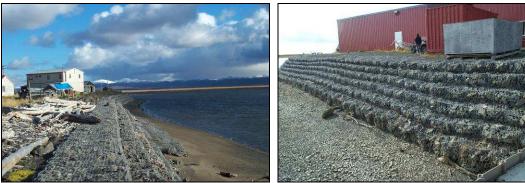
The Unalakleet shoreline.

Typical rock filled gabion bank protection

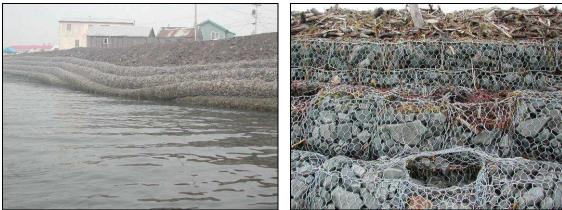
Sagging Gabion Wall

Typical Gabion Cell Rupture

The existing bank protection at Unalakleet is in need of major repair or replacement. The gabion structure has been ruptured in places, spilling the rock core out where it can easily be washed away even during good weather conditions. The Corps is developing a project to remedy the erosion in this location through the construction of a riprap revetment with an estimated cost of about \$30,000,000.
